W0-A-0061

PRELIMINARY GEOLOGICAL  
DAM SITE ASSESSMENT REPORT  
BAMYAN PROVINCE

November 25, 2010

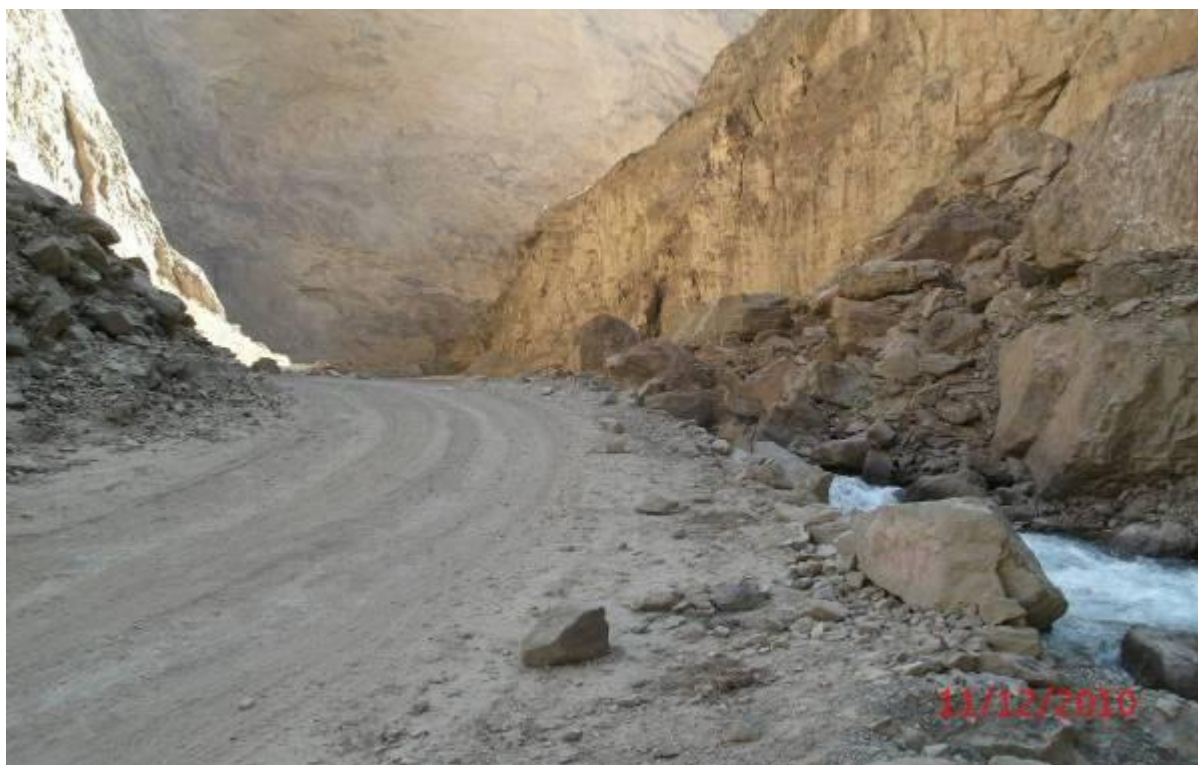
Looking southeast (upstream) from northeast bank position

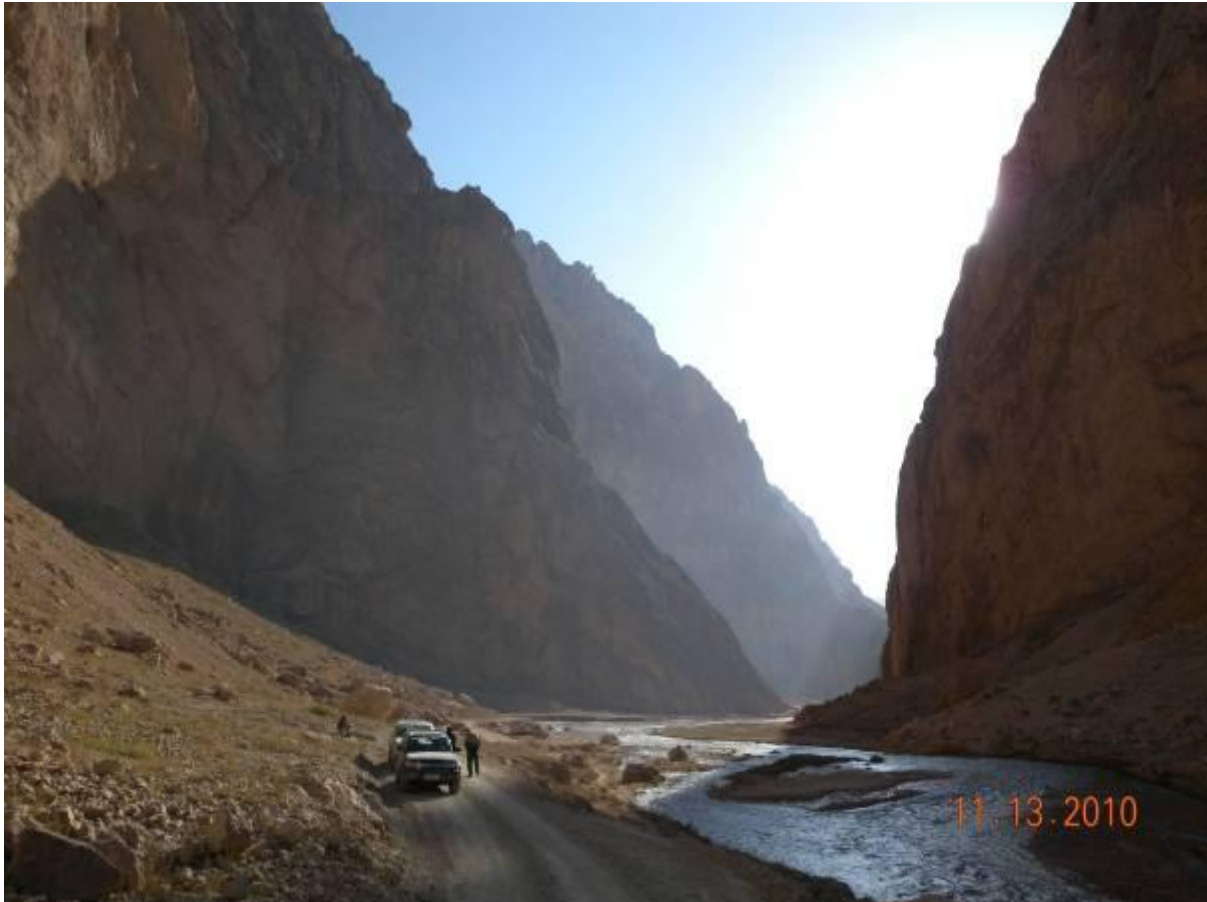
Looking south (upstream) from northeast bank position

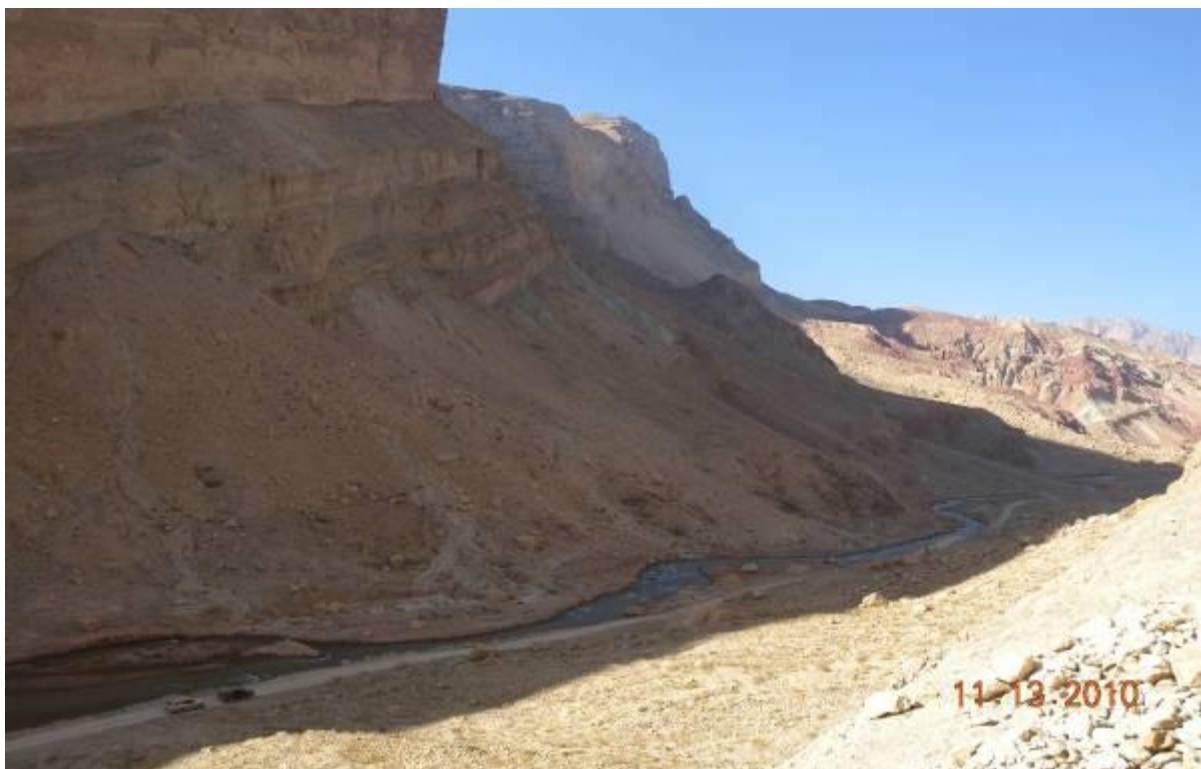
Looking northwest from high northeast bank position

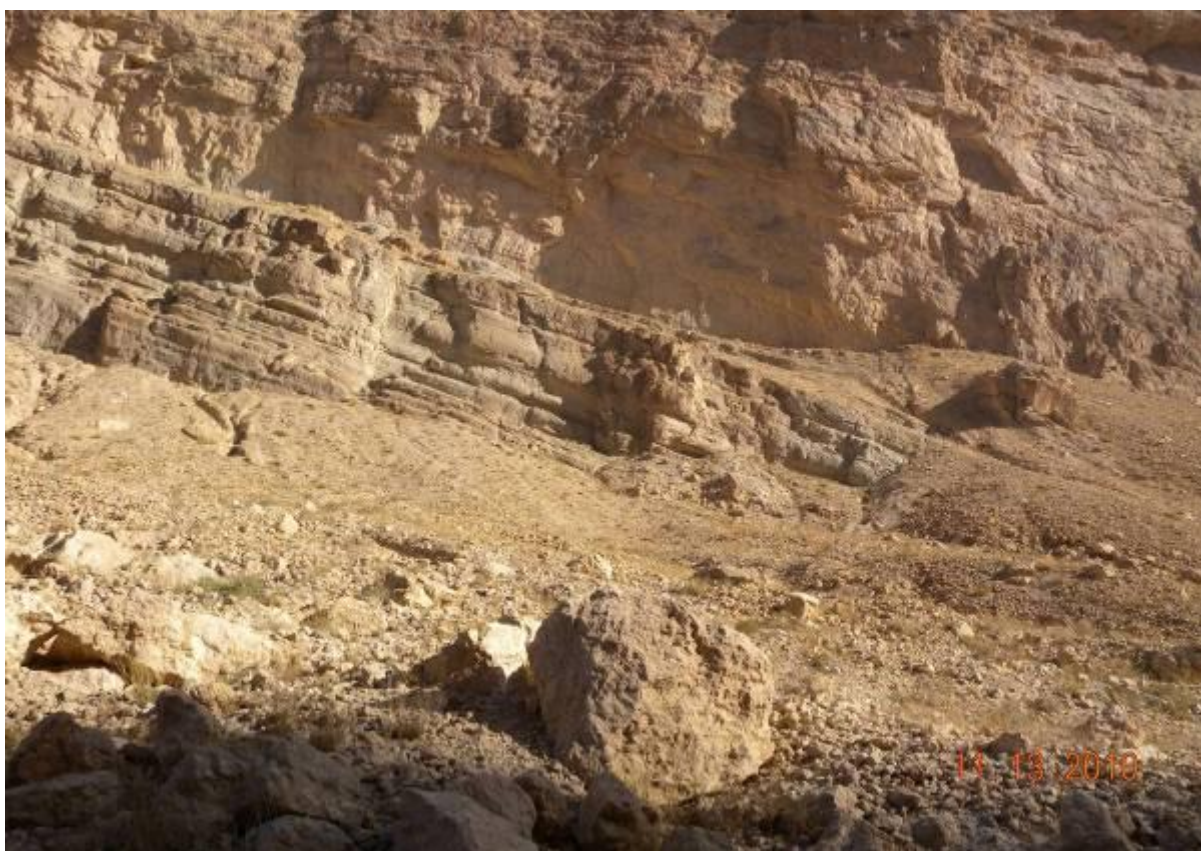
Looking northeast from northeast valley floor position

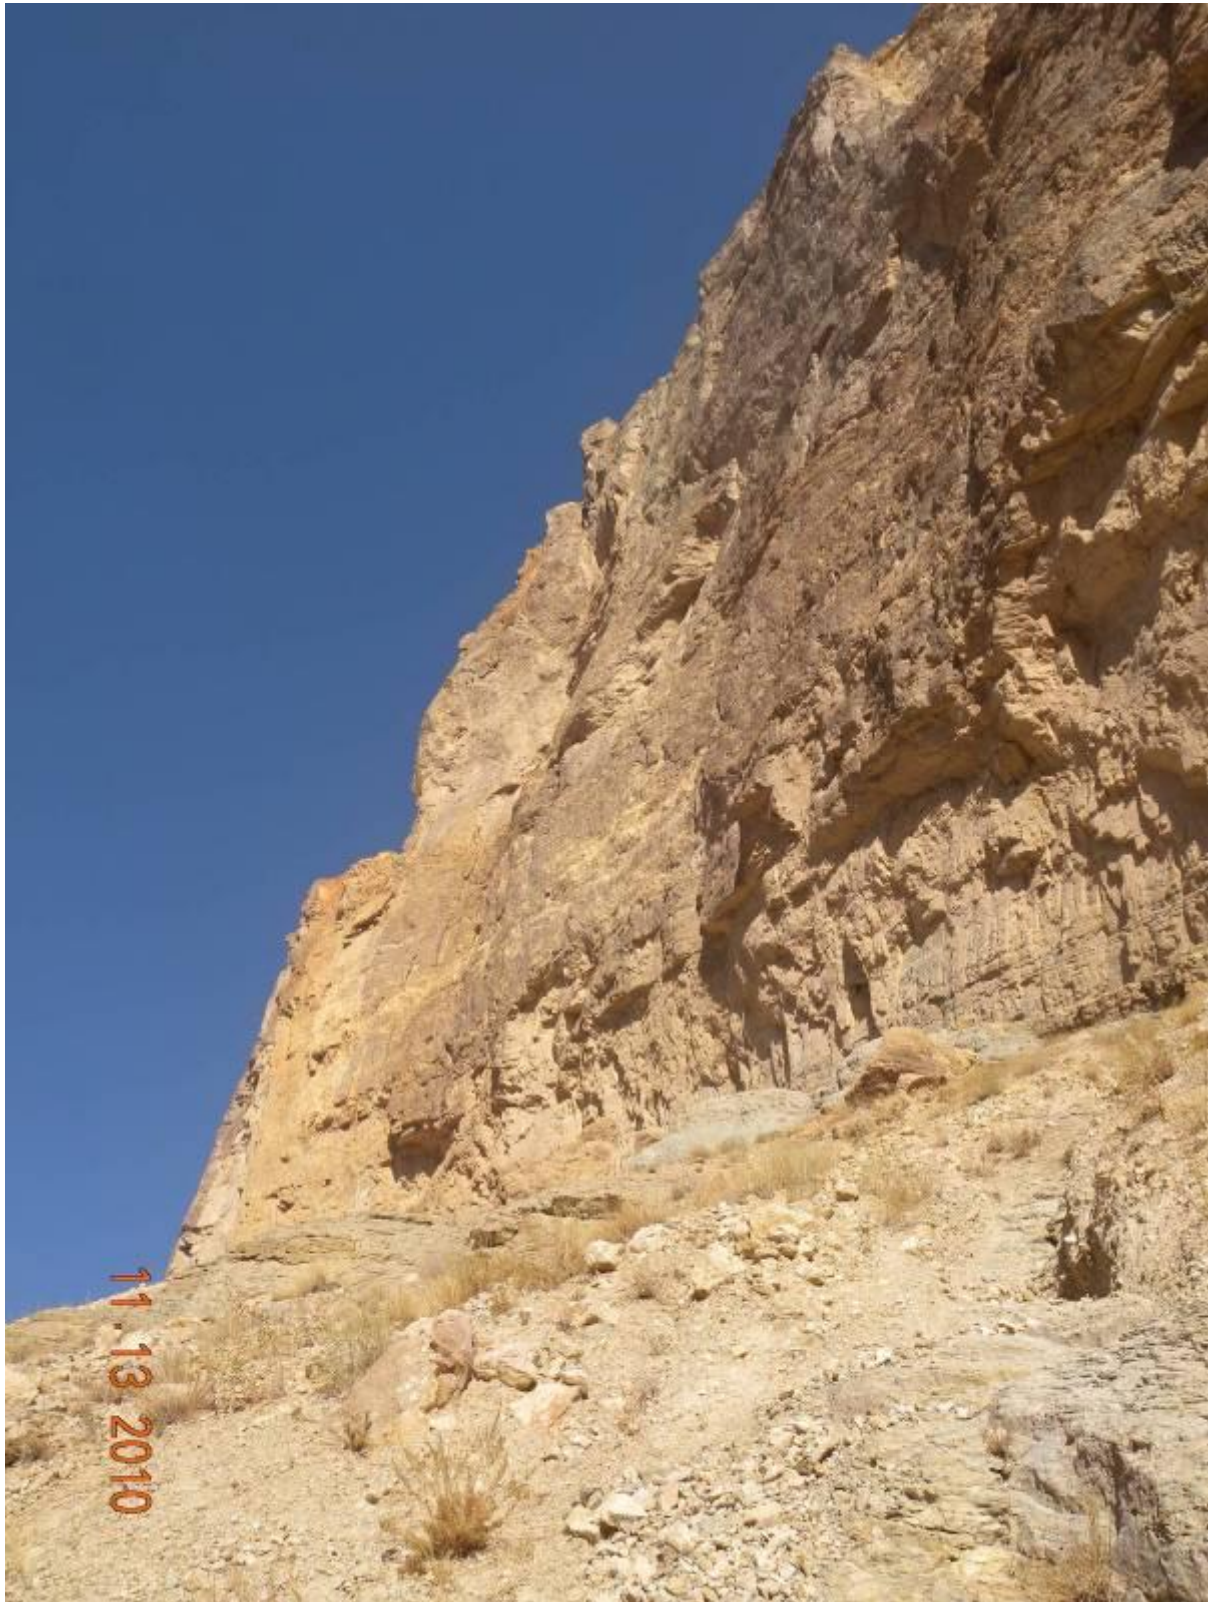
Looking northeast from mid-height northeast valley position
